Wellman Robey Steam Boiler House Installation

The Marketplace for Surface Technology.
New and Used Process Equipment & Machinery.
Machine Datasheet

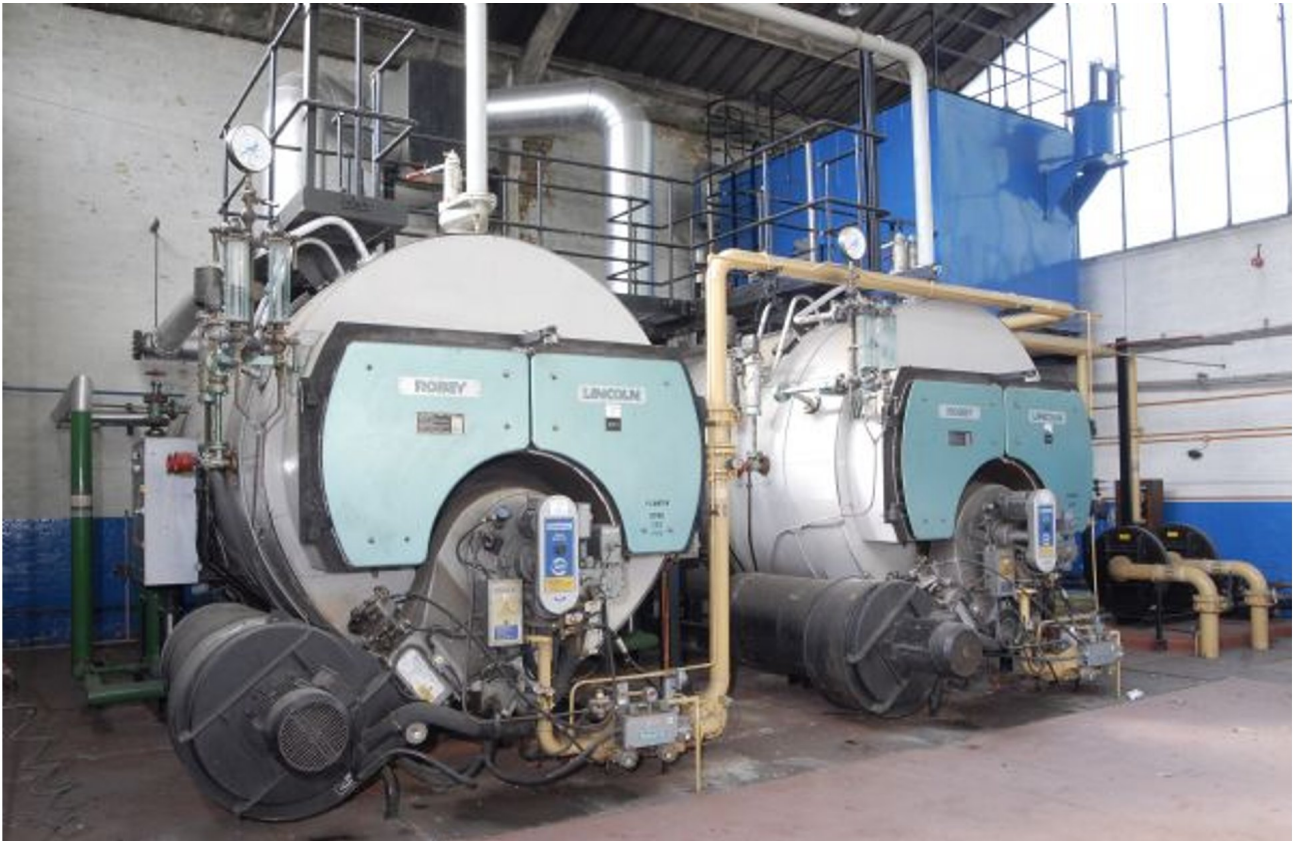
Stock No	MS357S
Serial	B/5379 /80
Work Envelope (WxDxH mm)	2900 x 5500 x 3300 each boiler
Process Stages	Triple pass reverse flame wetback boiler
Other Info	Complete with all associated equipment
Location	Aldridge
Weight (kgs)	2900 x 5500 x 3300 each boiler

The boiler house installation comprises primarily of two Wellman Robey Lincoln boilers with fitted Harmworthy dual fuel fully modulating burners rated continuously at 10,000 lbs/hr @ 100psi (4500kg/hr).
